# **Air Brake Failure- Automatic Slack Adjuster (ASA) - Air Brake Chamber Failure Analysis**

**David A. Stopper, Director  
Stopper & Associates  
Commercial Vehicle Safety  
Highway Collision Research &  
Reconstruction**

June, 2005

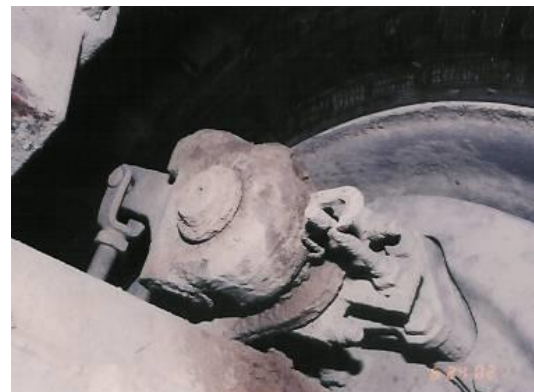
Haldex™ ASA – Control arm worn through anchor bracket & excessive wear at clevis pin bushing

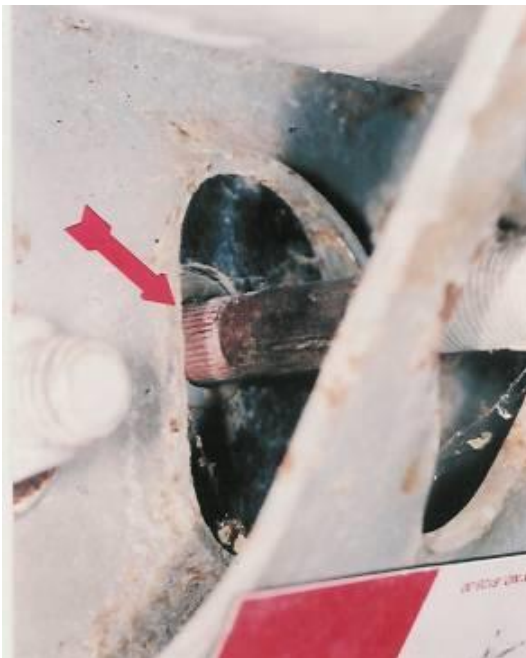
Exposed “Stroke Alert Indicator”  
Brake at maximum stroke

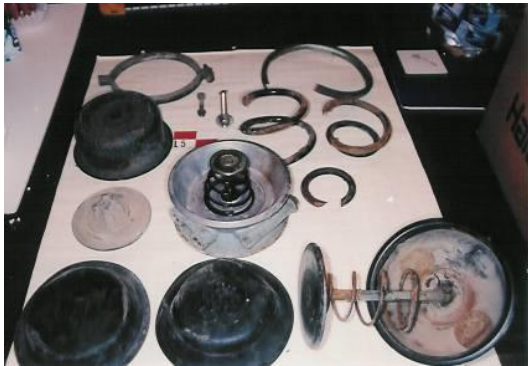
*“The parking/emergency brake spring was found to be in three pieces when brake disassembled. After a manual caging bolt was installed, the chamber retracted an additional 5/8 inch, indicating that the broken spring was preventing full pushrod release. The spring was fractured in such a way that it prevented full return of the pushrod; thus, the automatic slack adjuster did not have the minimum 1½ inches of*

In this case it became apparent three brake chambers inspected were at or near maximum stroke (bottomed out) but still measured to be at or near allowable push rod stroke limits. Further examination through the “Caging bolt” hole at the end of the brake chamber revealed a tilted pressure plate. NTSB investigators removed the suspect air brake chambers and had a manufacturer’s laboratory disassemble them exposing the fractured power springs.

Disassembled Type 30/30 brake chamber with fractured power spring

Inspection of a service-spring brake chamber suspected of a fractured power spring requires great care. Disassembly should NEVER be attempted except by a professional equipped with a proper compression press and safety cage. Failure to do so could result in serious injury or death. Visual inspection, without dismantling can be conducted with a bore scope.

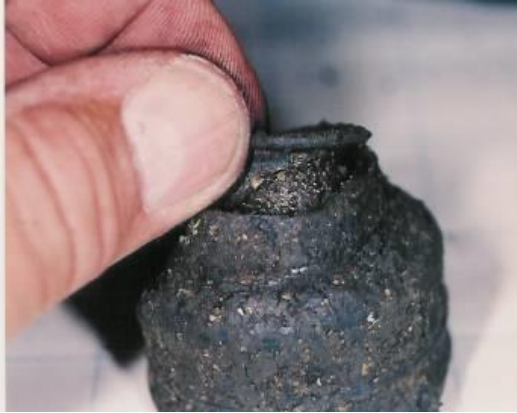
Worn adjusting link rubber boot

Worn rubber boots, protecting internal parts must be inspected. If worn or torn, the ASA must be disassembled, cleaned and the boot replaced. Often labor cost exceeds the value of simply replacing a worn ASA.

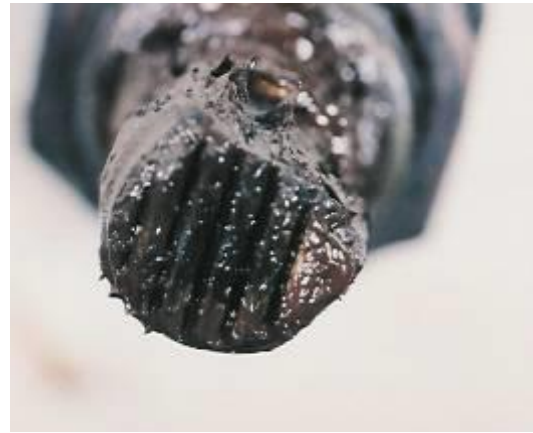
Drivers and mechanics often insist on manually adjusting ASAs. In the case of Meritor ASAs, the adjusting pawl, which locks the adjusting sleeve preventing the worm gear from backing off, like a ratchet wrench, can be damaged by manual adjustment.

Worn/damaged Rockwell / Meritor ASA adjusting pawl
