# Commercial Motor Vehicle Air Brake Failure Analysis

**David A. Stopper, Director**  
**Stopper & Associates, LLC**  
**Commercial Motor Vehicle Safety**  
**Highway Collision Research & Reconstruction**

# TRACTOR TRAILER vs SCHOOL BUS MULTIPLE FATALITY INVOLVING MULTIPLE BRAKE FAILURES

**Collision Between Truck-Tractor  
Semitrailer and School Bus  
Near Mountainburg, Arkansas  
on May 31, 2001**

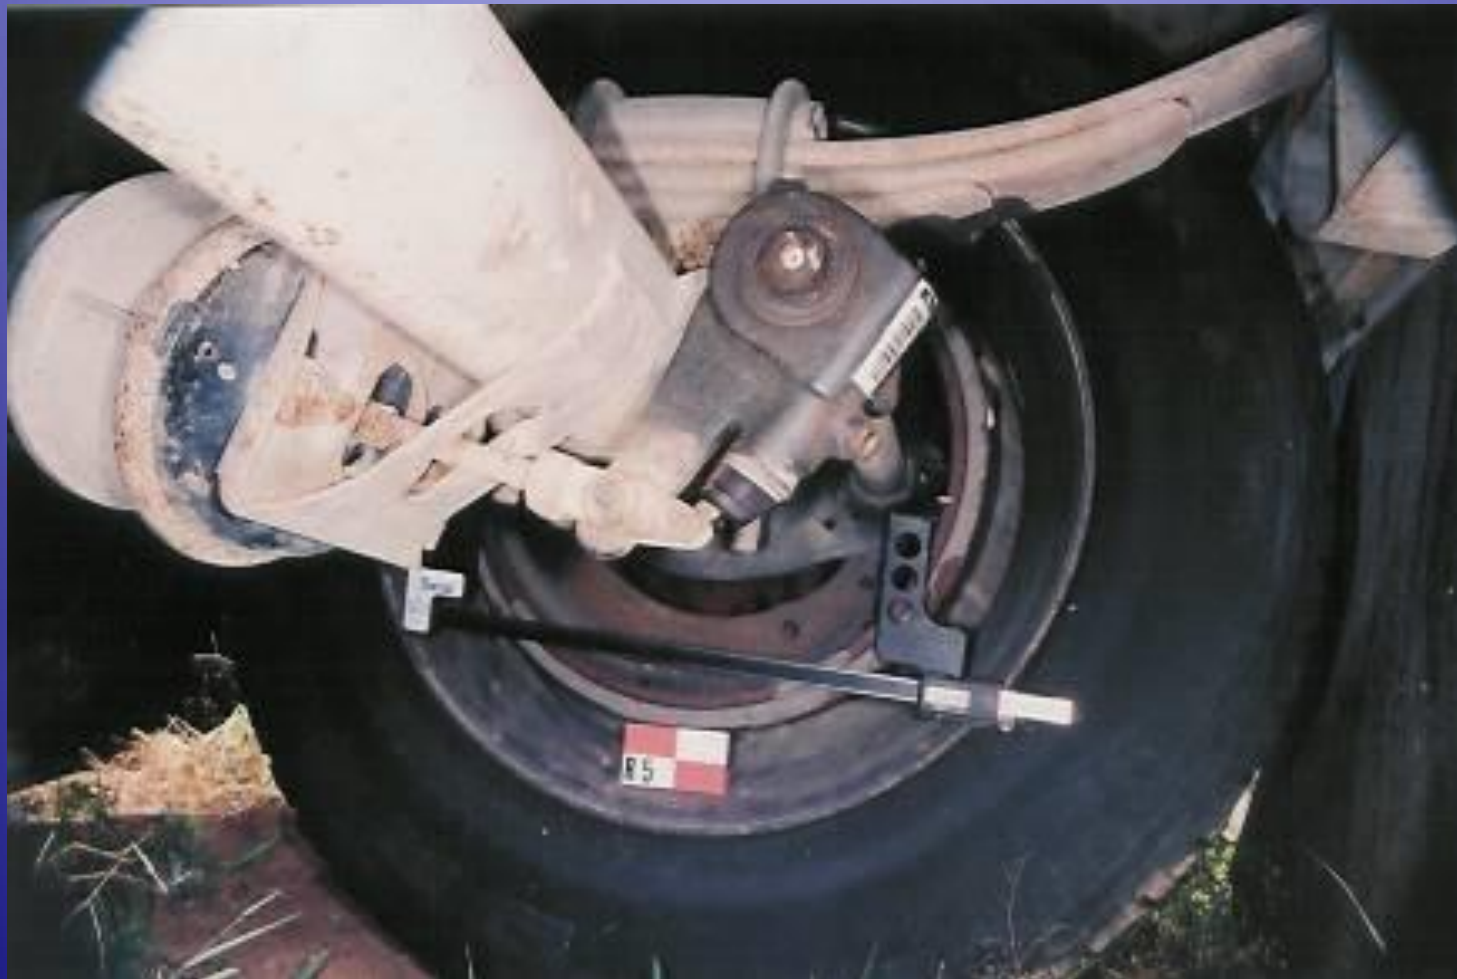
# Type 30/30 brake chamber with Meritor ABA

(Note: Central Tools™ “Wheels On” brake drum gauge)

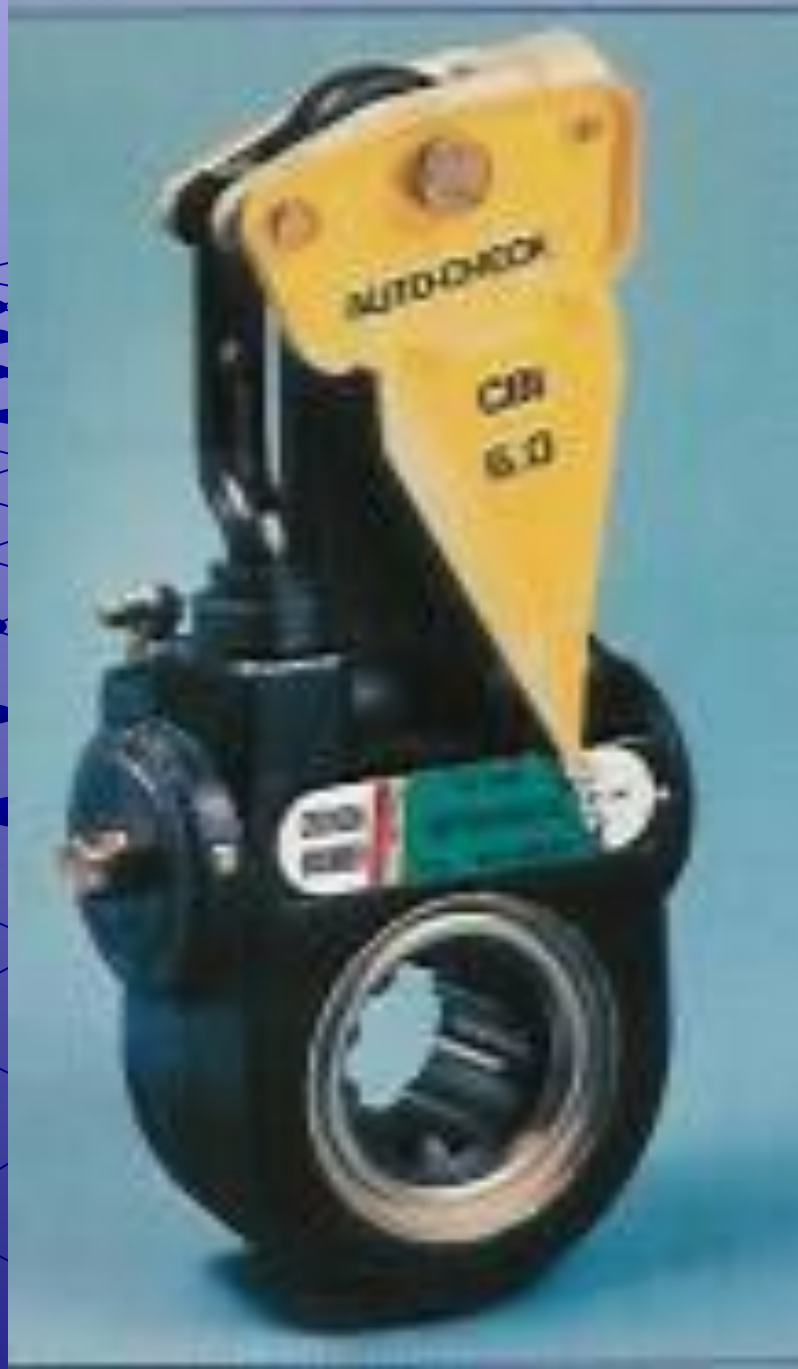
## Crewson-Brunner ASA

- The Crewson-Brunner ABA has incorporated a unique permanently mounted template which easily allows a driver to evaluate brake adjustment.

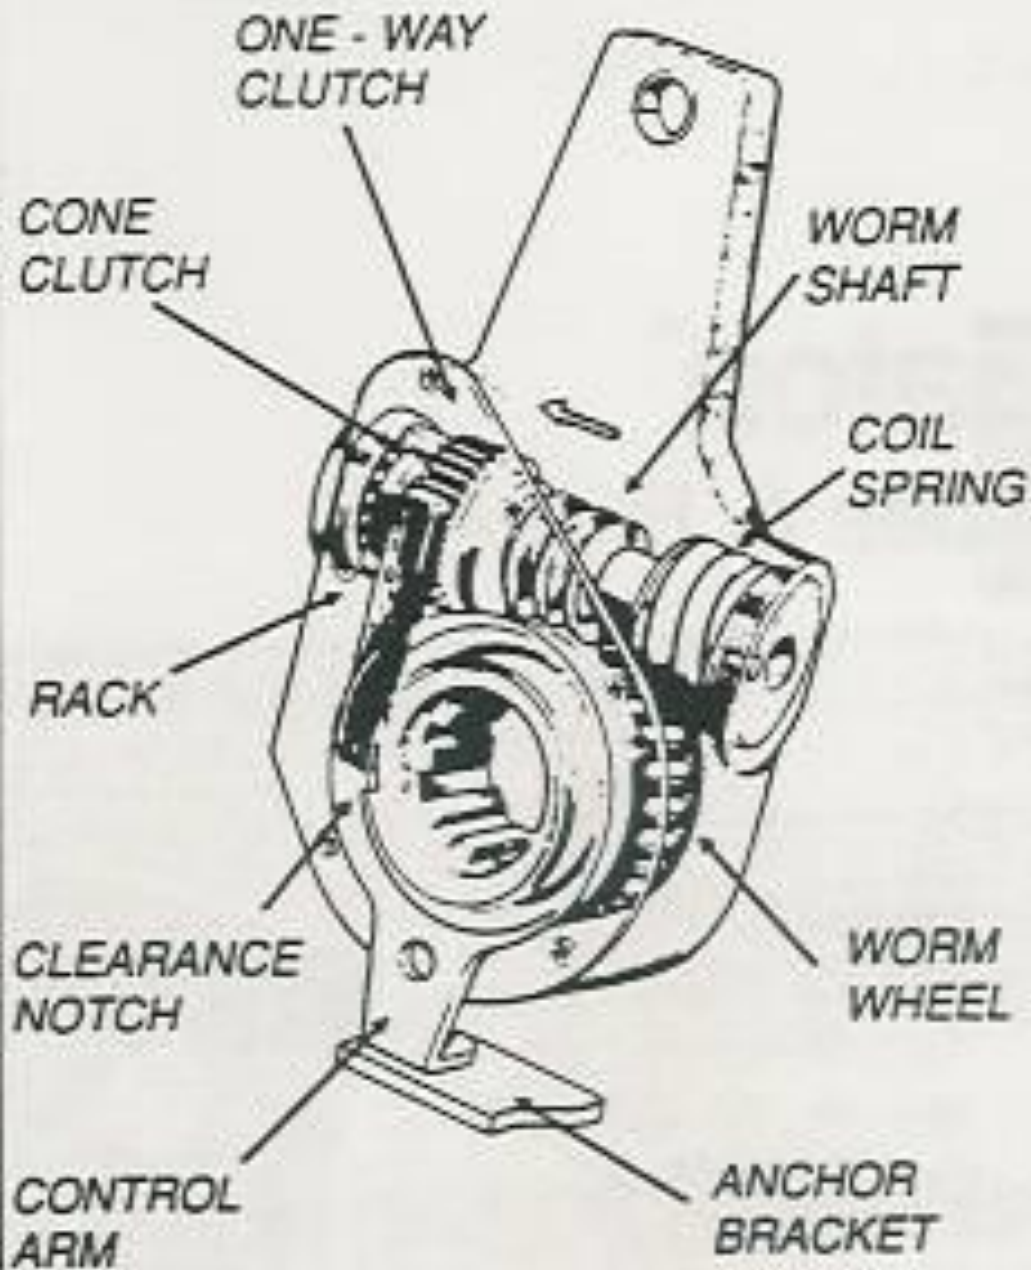
# Haldex S-ABA

- The second ASA design unique to the Haldex S-ABA™ (Self Setting Automatic Brake Adjuster) utilizes an anchor bracket.
- The anchor arm is then attached to a fixed point by a bracket typically attached to the axle, brake spider or to a mounting bolt of the air brake chamber

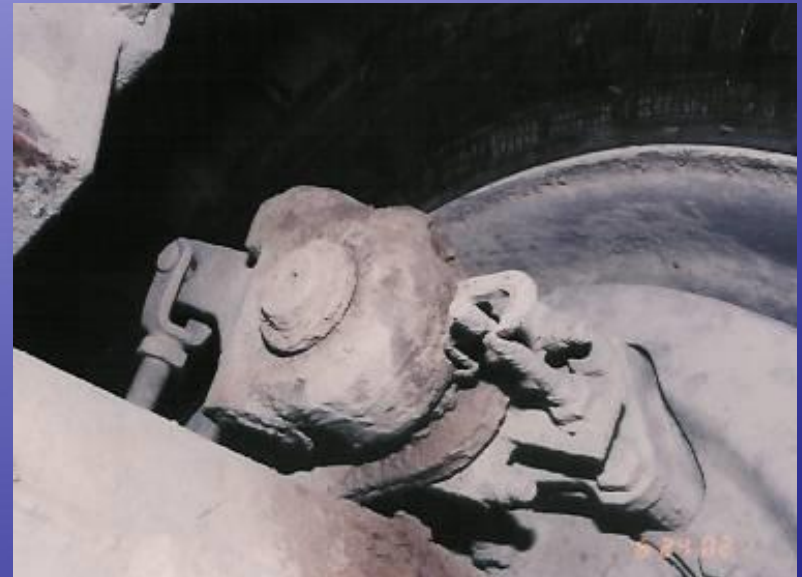
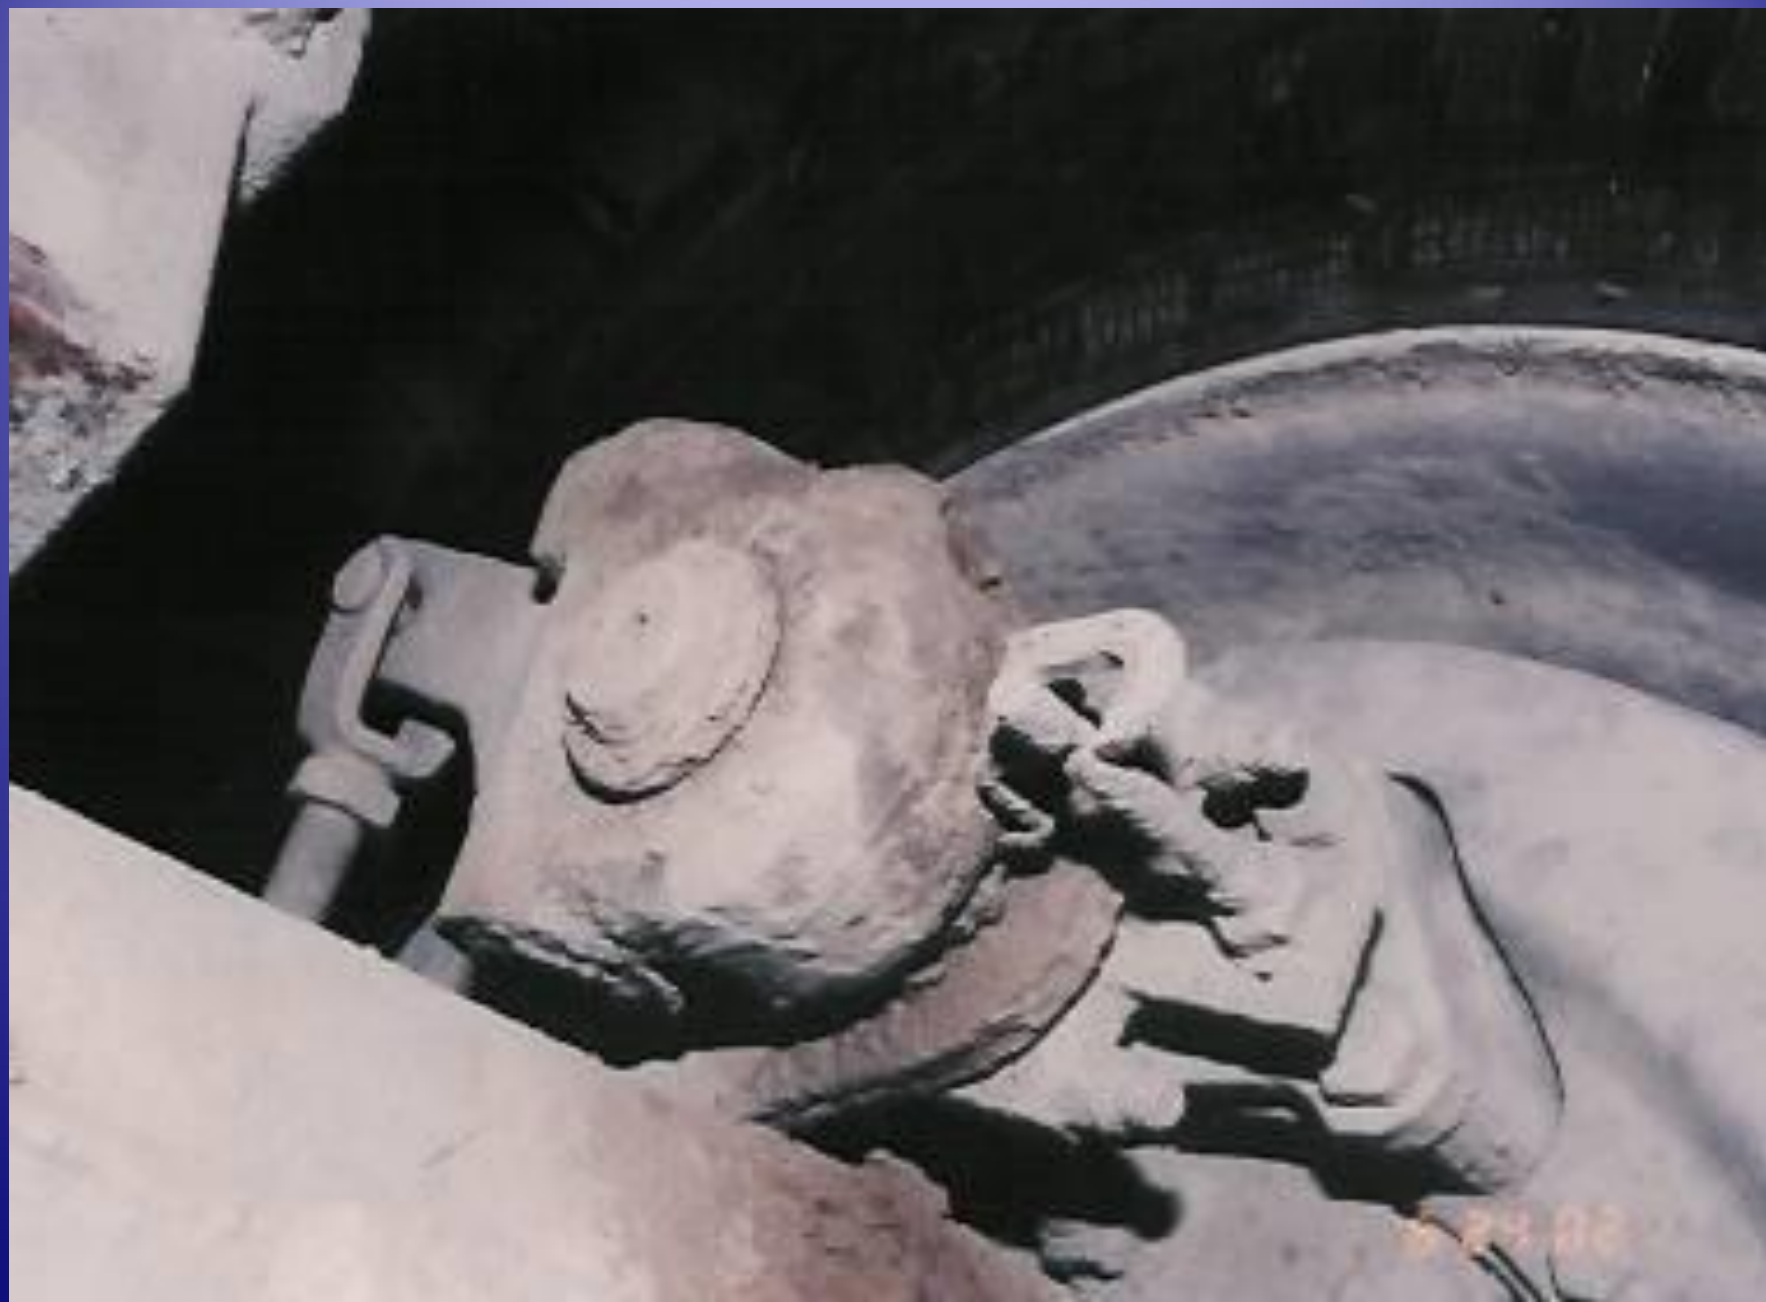
# Example of defective Haldex ABA

- Adjusting link (Anchor bracket) has worn through
- Clevis pin bushing worn out – Excessive play
- NTSB has reported finding Haldex ABA backing off adjustment when anchor bracket is loose.
- Result of poor maintenance

- WORN ADJUSTING LINK:

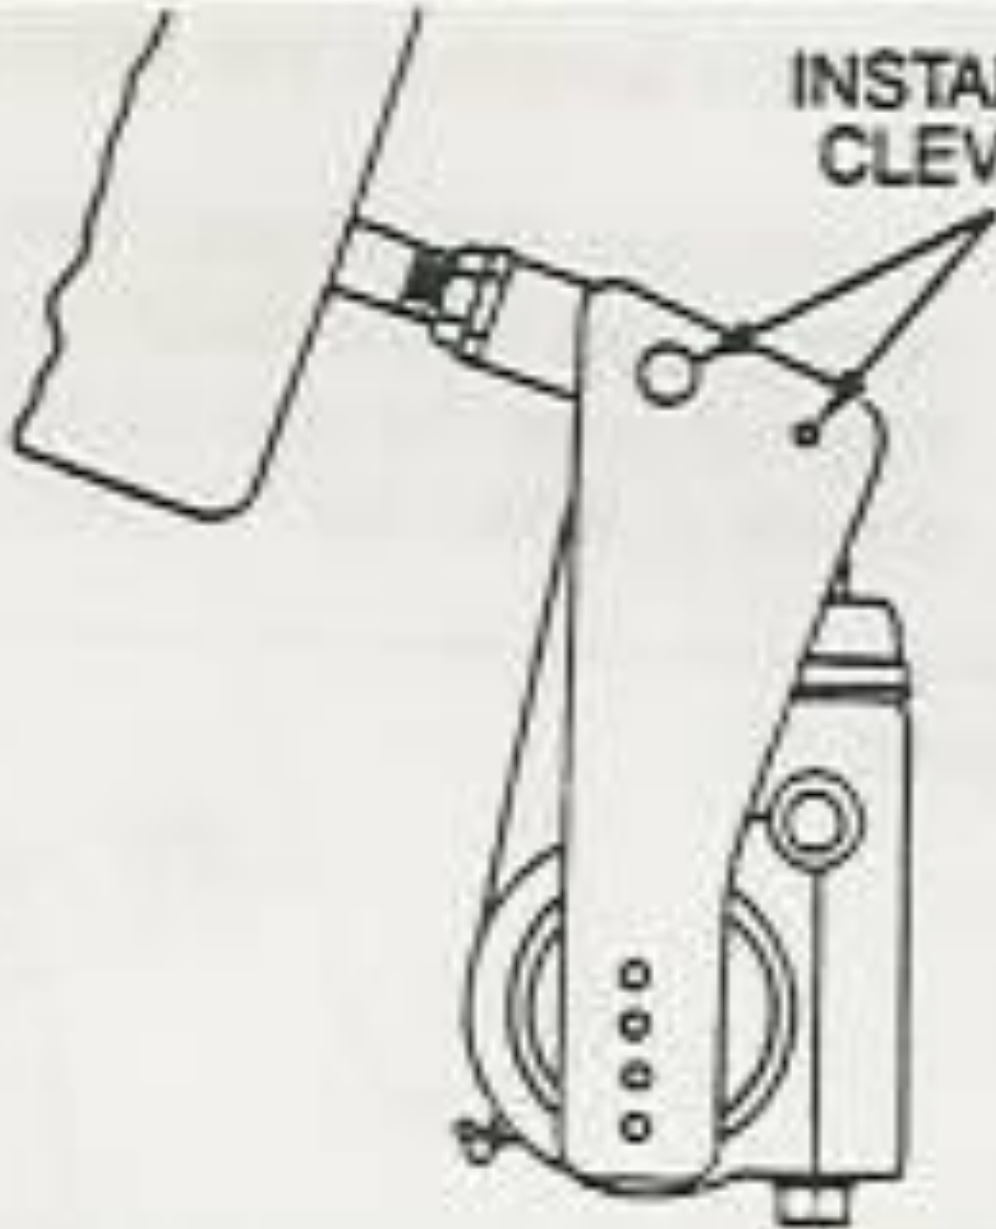
# Adjusting Link Geometry

- The geometry, more commonly referred to as installation angle, is critical to proper function of ASAs equipped with a pushrod clevis actuated adjusting link.
- The angle created by the three center points between the cam shaft, clevis pin and adjusting link clevis pin are critical
- The ASA must be checked with a template supplied by the manufacturer.

**INSTALL BOTH  
CLEVIS PINS**

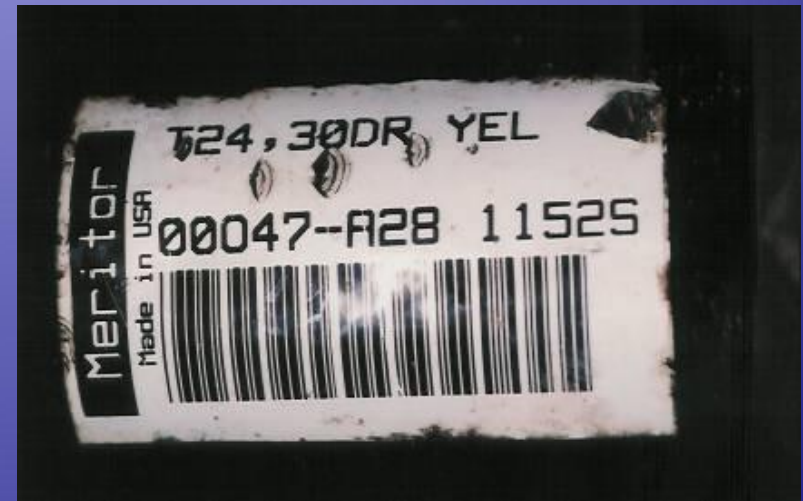
- Meritor ABA Identification

- Meritor (formerly Rockwell) uses a color coding system
- The nylon strap tie that secures the rubber boot is a different color for various air chamber “Type” sizes.
- color coded nylon strap has been eliminated however the “color” is still referenced

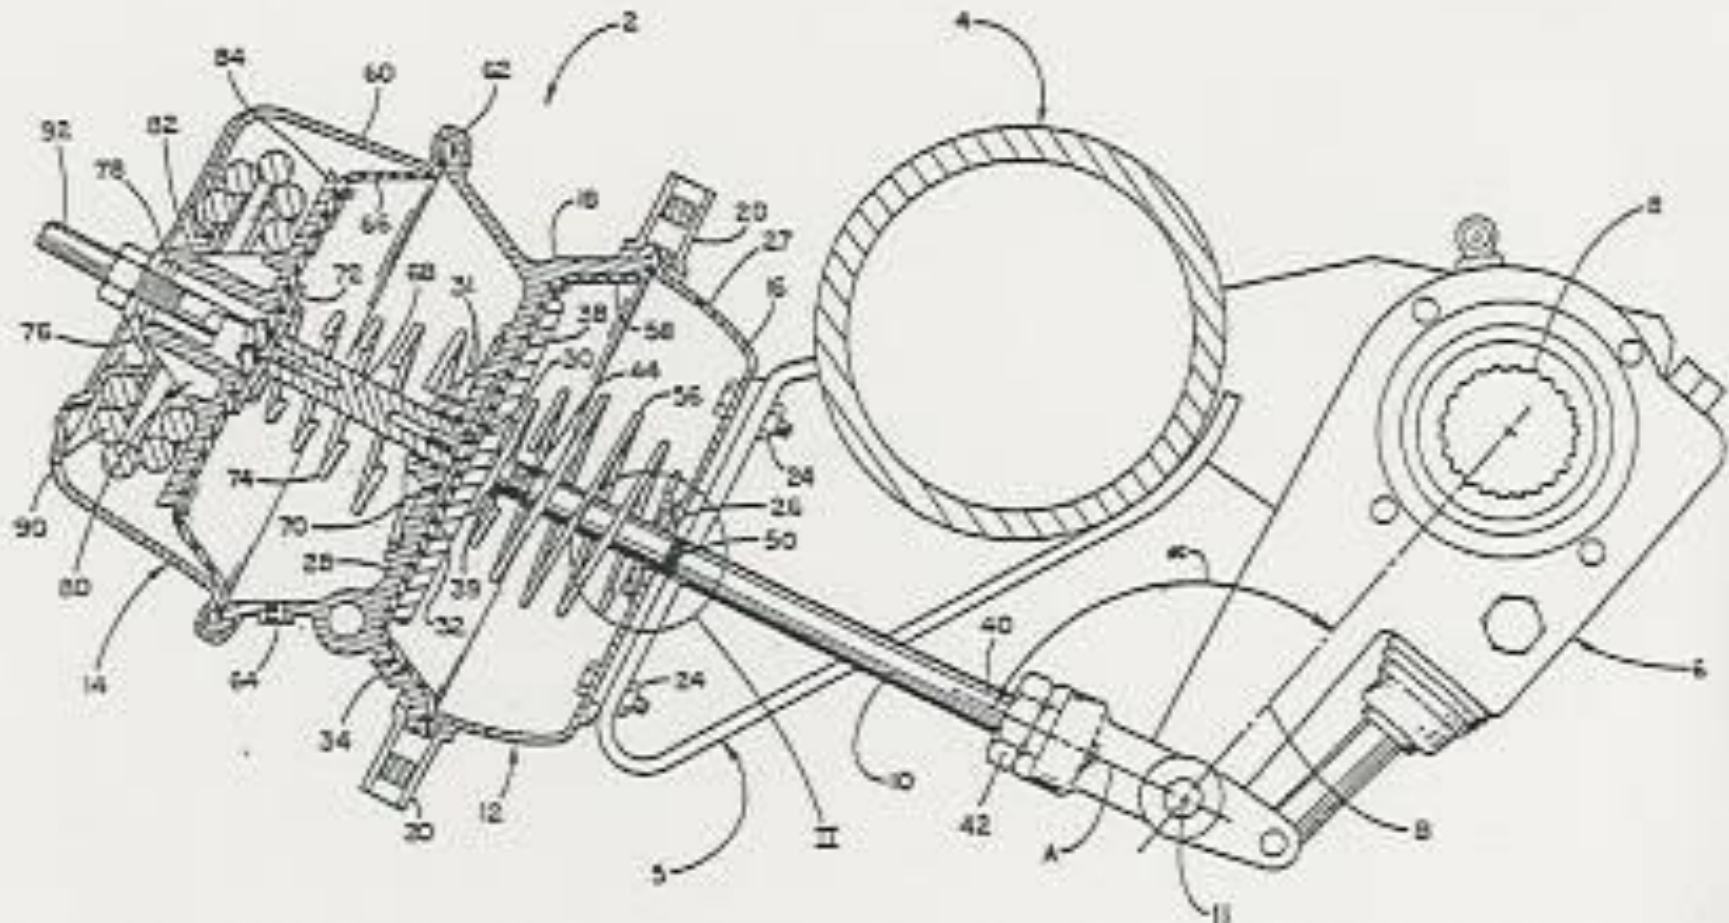
# Push Rod Length

- New air brake chambers generally are provided with a 12 inch push rod which must be cut to proper length
- If cut too short, when the slack adjuster it may contact axle components
- This prevents the ASA from completing a full apply to release cycle and will not allow proper automatic adjustment.

- *“During the post accident inspection, investigators discovered that the angle between the pushrod and the slack arm on brake 4R (semitrailer left leading axle) was greater than the 90 degrees that specifications allowed. When measured against a slack adjuster template, the pushrod was about 1 inch shorter than the pushrod on the left side of the trailer, causing the greater angle. According to the manufacturer, the automatic slack adjuster was bottoming out, thus preventing full release of the pushrod and preventing the brakes from automatically adjusting. The 4R brake drum was rusty and the brake did not appear to be functioning.”*

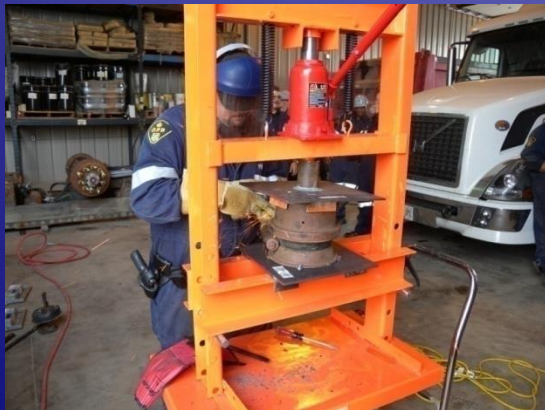
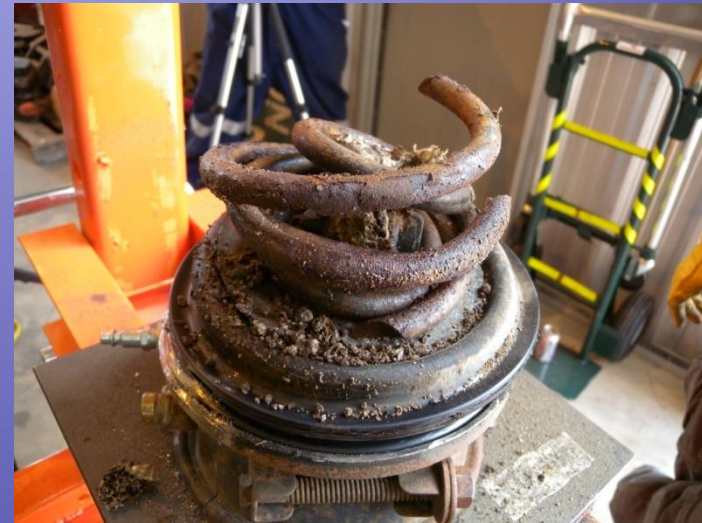
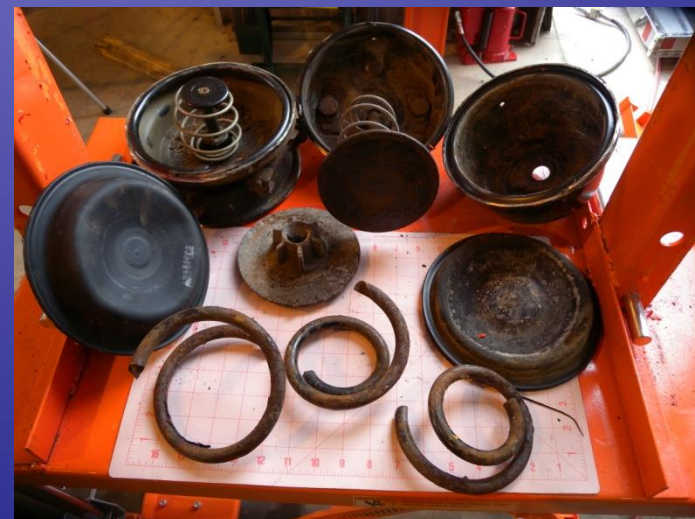
# FRACTURED PARKING BRAKE POWER SPRING

**Reference: Mountainburg, AR 31MAY2001 NTSB/HAR-02/03 PB2002-916203**

WORN OR DEFECTIVE SLACK ADJUSTERS MAY NOT FULLY RETRACT

- **FRACTURED SPRING BRAKES CAN PREVENT FULL RETRACTION**
- **AUTO BRAKE ADJUSTERS (ABAs) WON'T SELF ADJUST IF PUSH ROD IS NOT FULLY RETRACTING**

- *“The parking/emergency brake spring was found to be in three pieces when brake disassembled. After a manual caging bolt was installed, the chamber retracted an additional 5/8 inch, indicating that the broken spring was preventing full pushrod release. The spring was fractured in such a way that it prevented full return of the pushrod; thus, the automatic slack adjuster did not have the minimum 1½ inches of stroke necessary to activate the adjusting mechanism.”*

- *“A broken spring, which is difficult to detect, can reduce emergency-parking brake forces or render the emergency-parking brake inoperable, and the broken spring pieces can be displaced, thus shortening the pushrod stroke or preventing the automatic slack adjuster from functioning. The extent of the broken spring problem is undetermined.*”

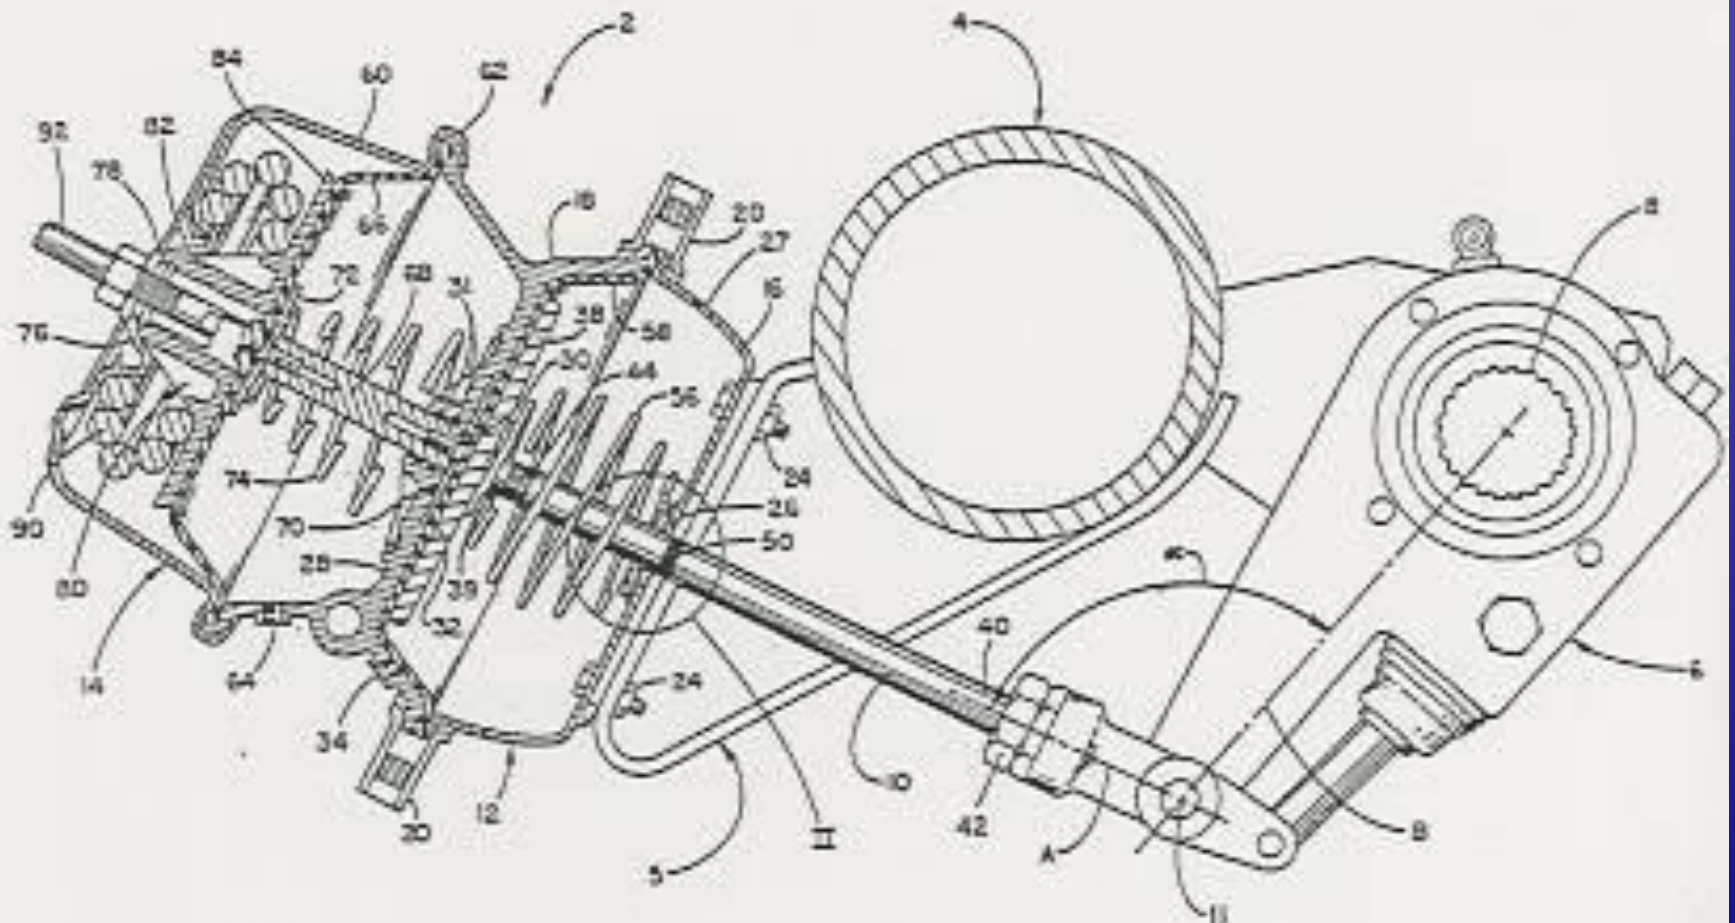
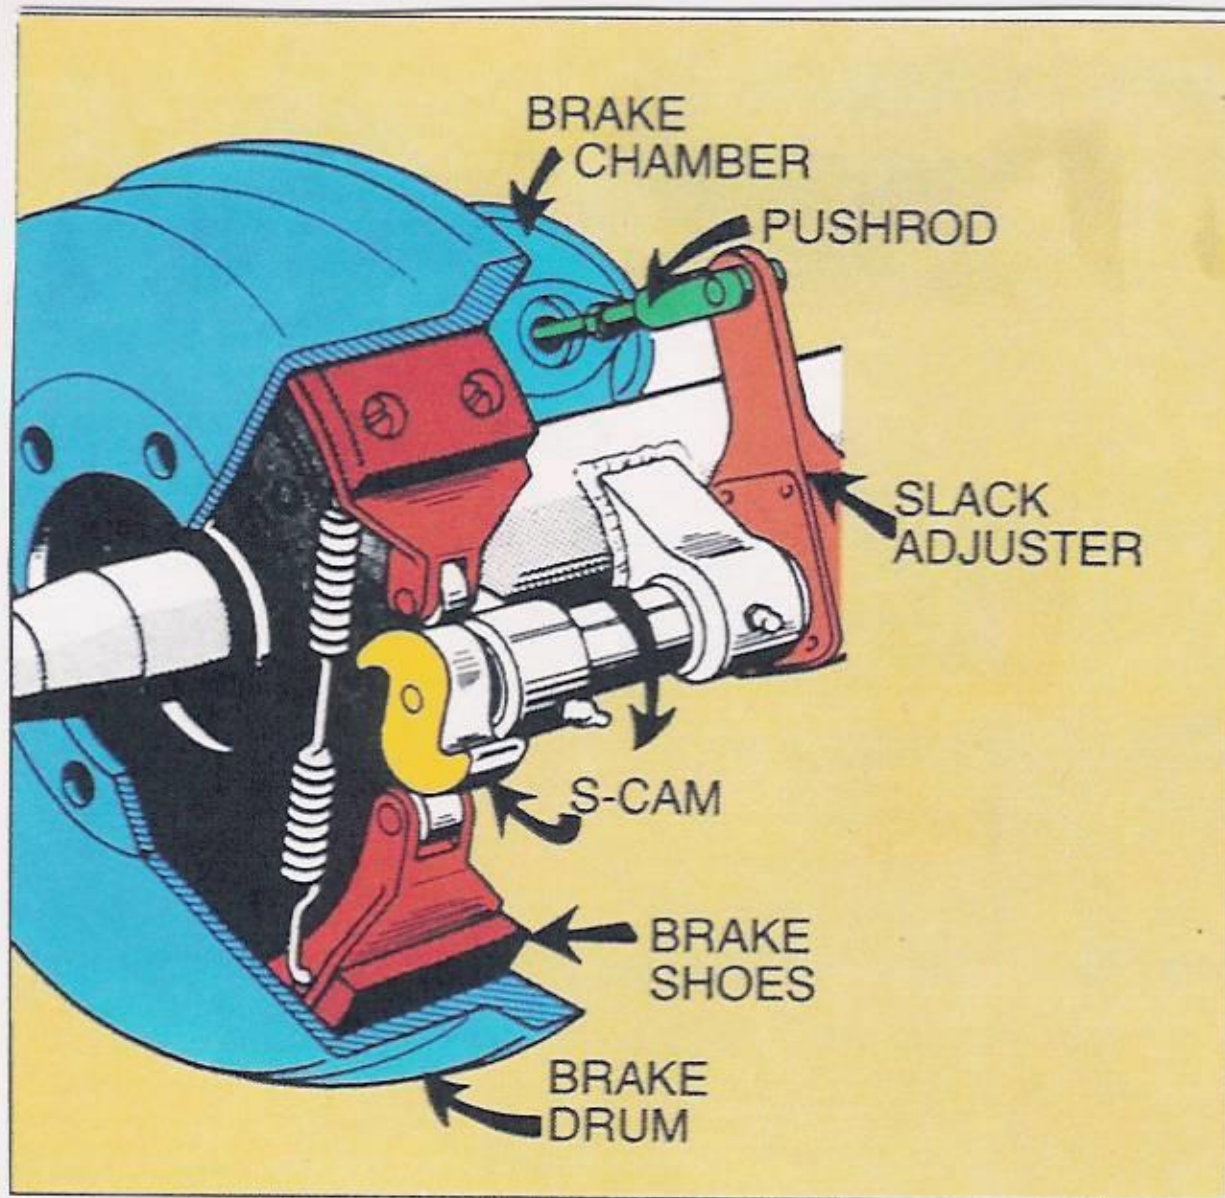
- Both service and service/spring air brake chambers are equipped with return springs to retract the push rod and slack adjuster to its fully released position.
- ASAs must return to the fully retracted position to adjust
- return spring needs a minimum of 32 pounds of spring force

*Foundation brake operation. When pushrod is extended, brake adjuster, camshaft, S-cam rotate. S-cam spreads brake shoes apart and against brake drum.*

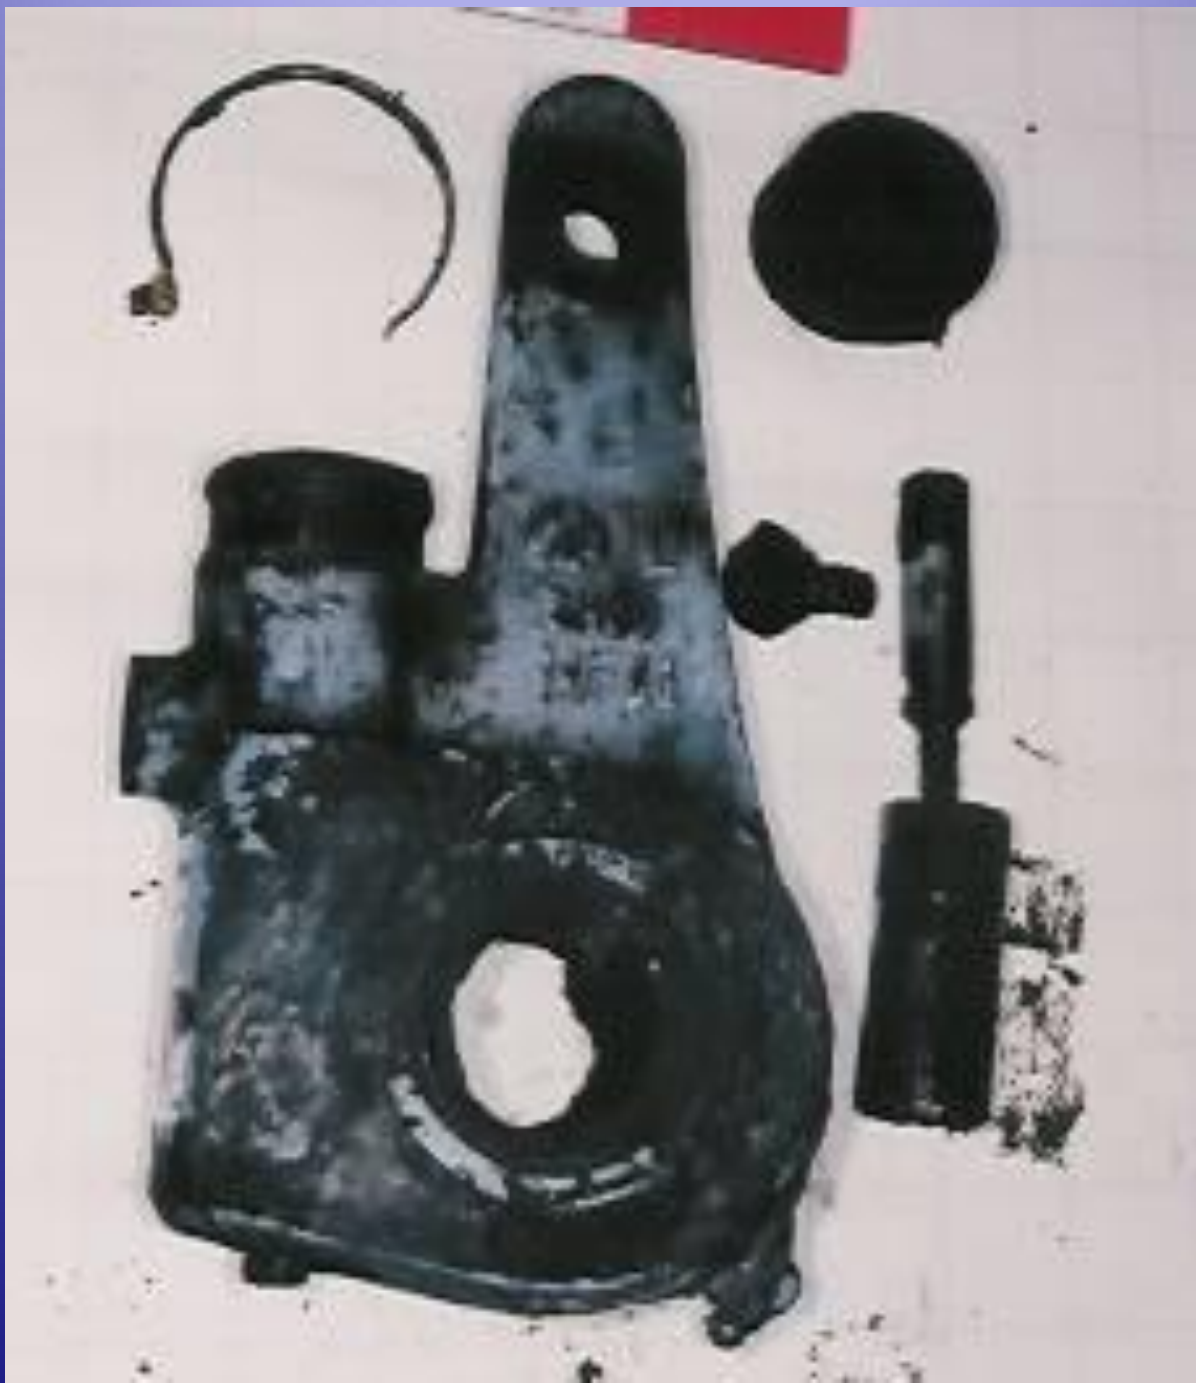
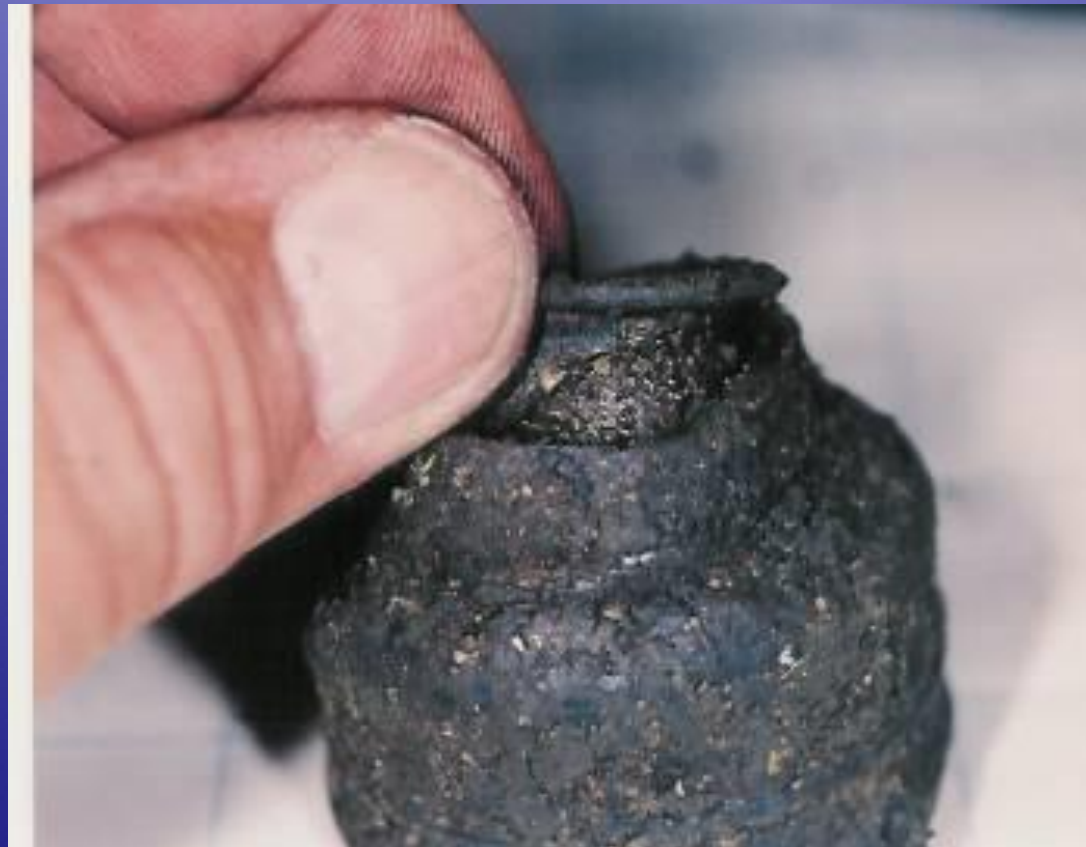
Internal adjusting mechanisms are sensitive to excessive dirt /moisture

- Worn rubber boots, protecting internal parts must be inspected

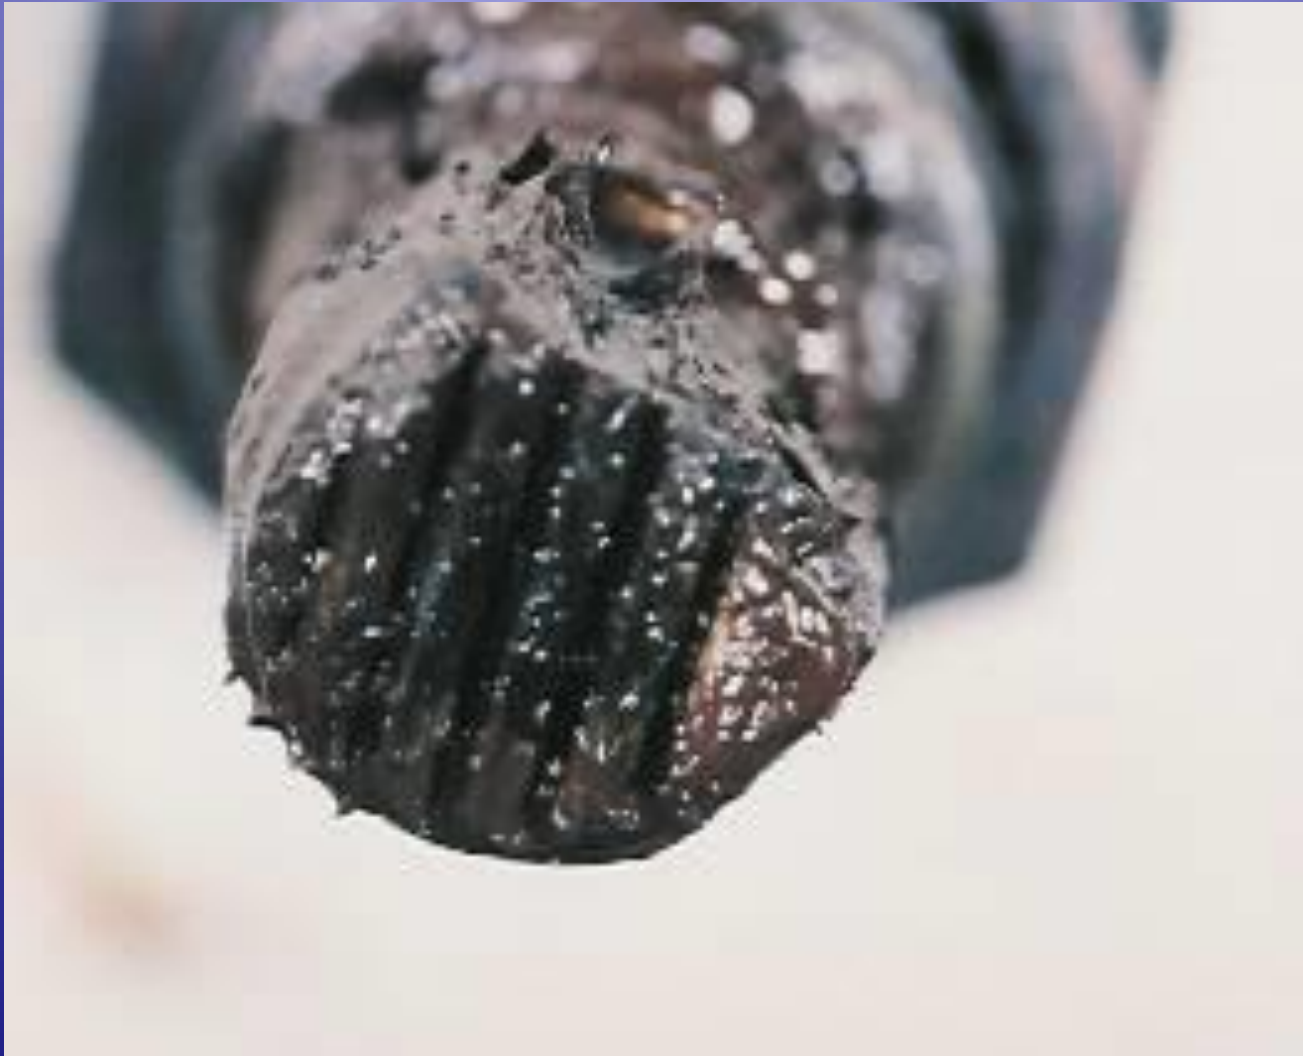
# Damaged Pawl

- Drivers and mechanics often insist on manually adjusting ABAs
- Meritor ABA adjusting pawl, can be damaged by manual adjustment.
- Meritor (formerly Rockwell) ABA “Pawl” must be disengaged during manual adjustment

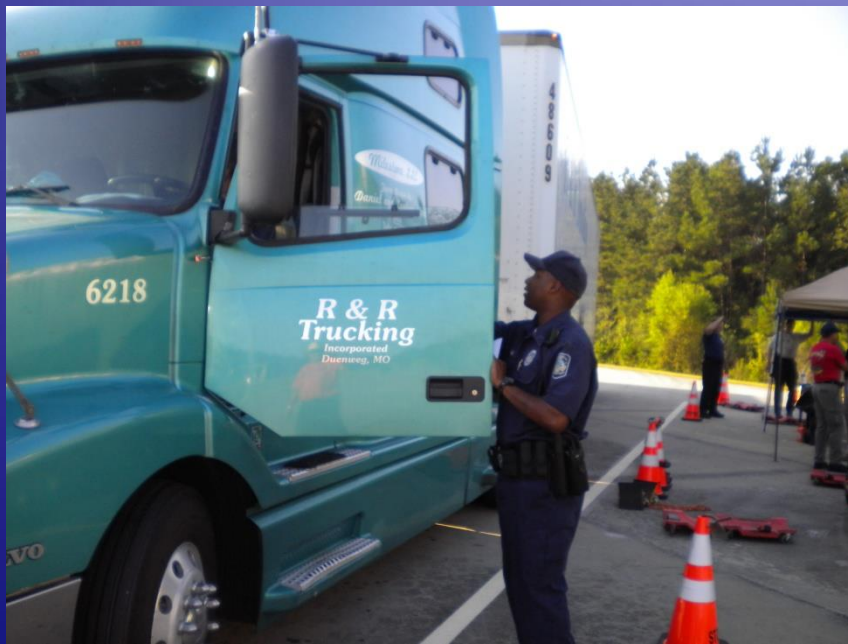
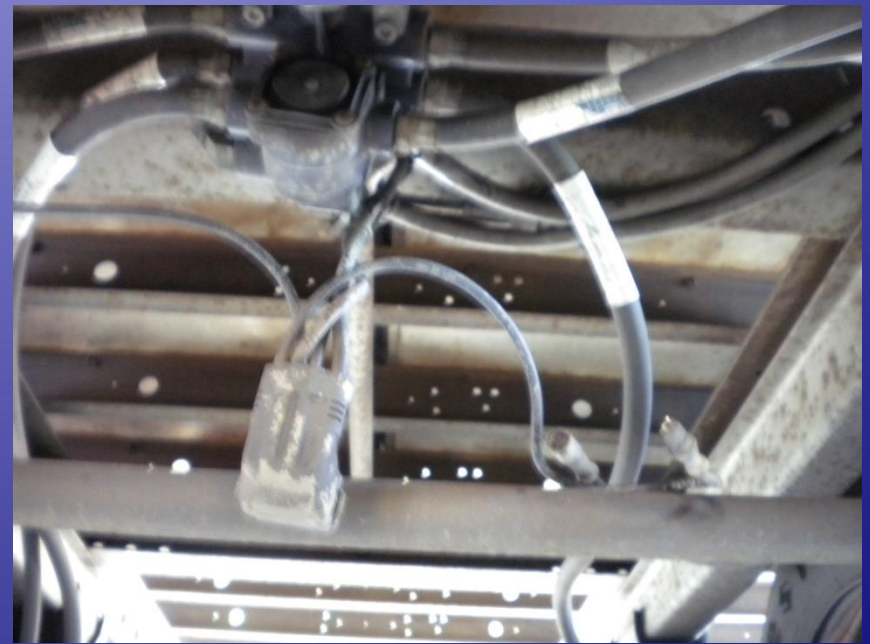
Disconnected ABS cable to relay valve – DEFECT:
