# **Air Brake Failure- Automatic Slack Adjuster (ASA) - Air Brake Chamber Failure Analysis**

**David A. Stopper, Director  
Stopper & Associates  
Commercial Vehicle Safety  
Highway Collision Research &  
Reconstruction**

June, 2005

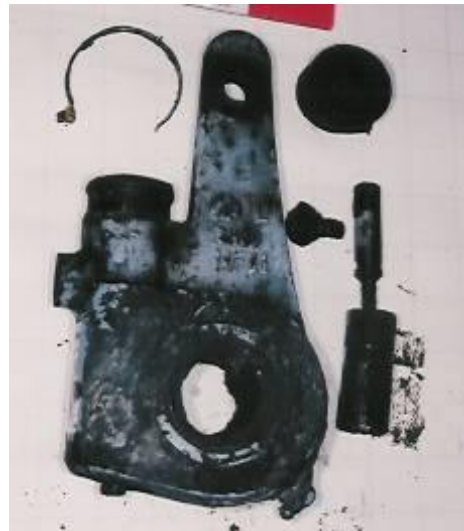
Disassembled Rockwell ASA

Internal adjusting mechanisms are sensitive to the introduction of excessive dirt and corrosion from road dirt.
